**INVESTIGATION INTO THE CIRCUMSTANCES  
SURROUNDING THE EXPLOSION AND FIRE  
ABOARD THE TANKSHIP**

**OMI CHARGER**

**ON OCTOBER 9, 1993, AT BOLIVER ROADS  
INNER ANCHORAGE NEAR GALVESTON,  
TEXAS, WITH INJURIES AND MULTIPLE LOSS  
OF LIFE**

## COMMANDANT'S ACTION

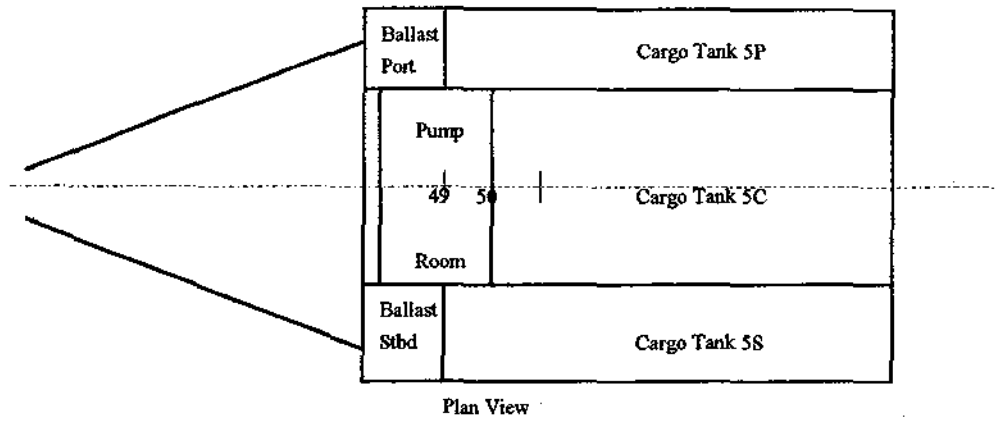
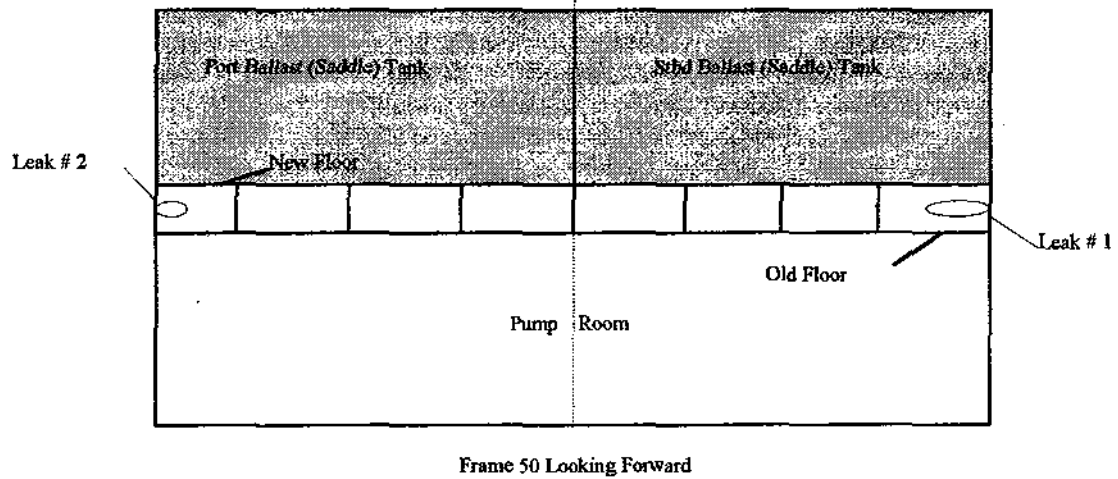
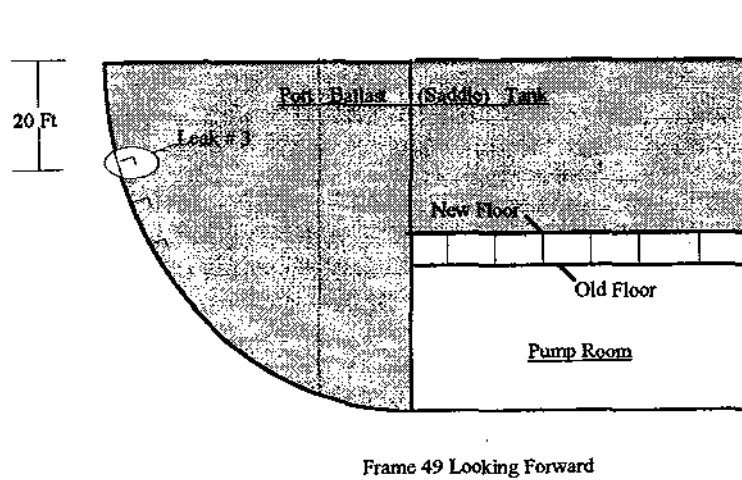
Figure 2, Location of Leaks (not to scale)

18. Three different blends of gasoline were loaded. At about 0330 on October 1st, the third mate, Tara Ziegler, making rounds in the pumproom, discovered a leak coming from the forward bulkhead between the pumproom and the 5 Center (5C) cargo tank. The leak was located on the starboard side, upper portion of the bulkhead, in between two horizontal plates that formed the overhead of the pumproom. This small space was created in the shipyard, as a result of modifications to the pumproom overhead, in an effort to correct problems in the saddle tanks (ballast) directly above the pumproom.

20. Sometime that afternoon, a second leak was discovered in the same bulkhead, in a similar location as the first, but on the port side of the pumproom. The rate of this leak was "just a drip" and the master was so notified.

26. The OMI CHARGER arrived Tampa, FL late Wednesday evening, October 6, and docked at the AMOCO facility about midnight. At approximately 0218 October 7th, the vessel began discharging cargo. Later that morning, Mr. [REDACTED] visited the ship and discussed a revised proposal to repair the leaks with the master and chief mate. He also reviewed the repair proposal with the chief engineer and Mr. Keith Kelly, a welder and foreman of the IMS workers, since the repairs involved hot work. On the leak in the forward pumproom bulkhead, starboard side (leak #1), the proposal was to gouge and weld the crack, then weld a "reinforcing plate" over the repair. They thought the other leak in that bulkhead, on the port side of the pumproom (leak #2), was just a bad weld and proposed to gouge and reweld it.

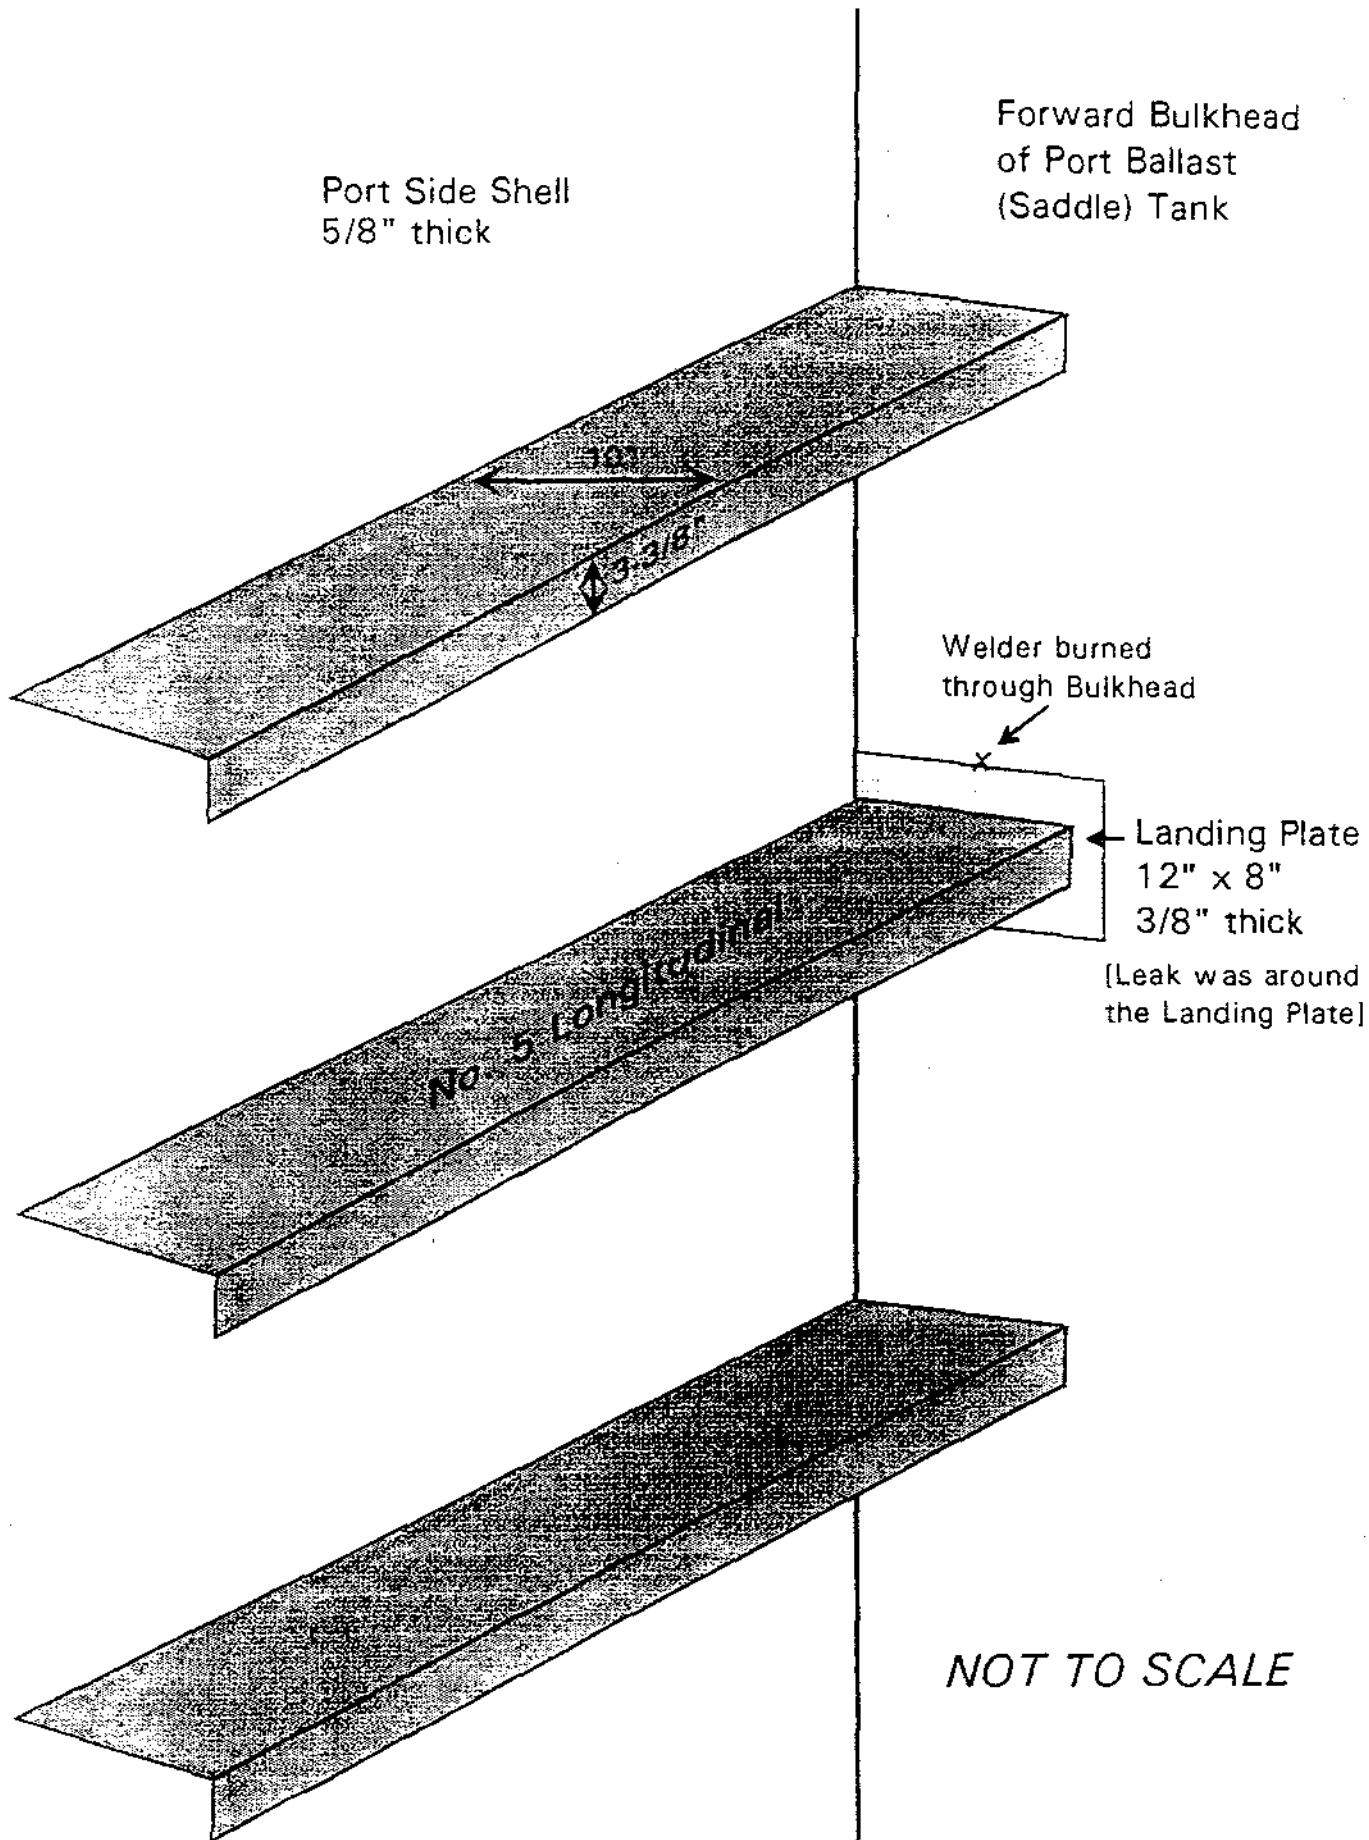
Figure 3, Location of Leak #3

27. The "weep" in the saddle tank (leak #3) was also thought to be a bad weld from the shipyard, and the proposal was to simply reweld it.

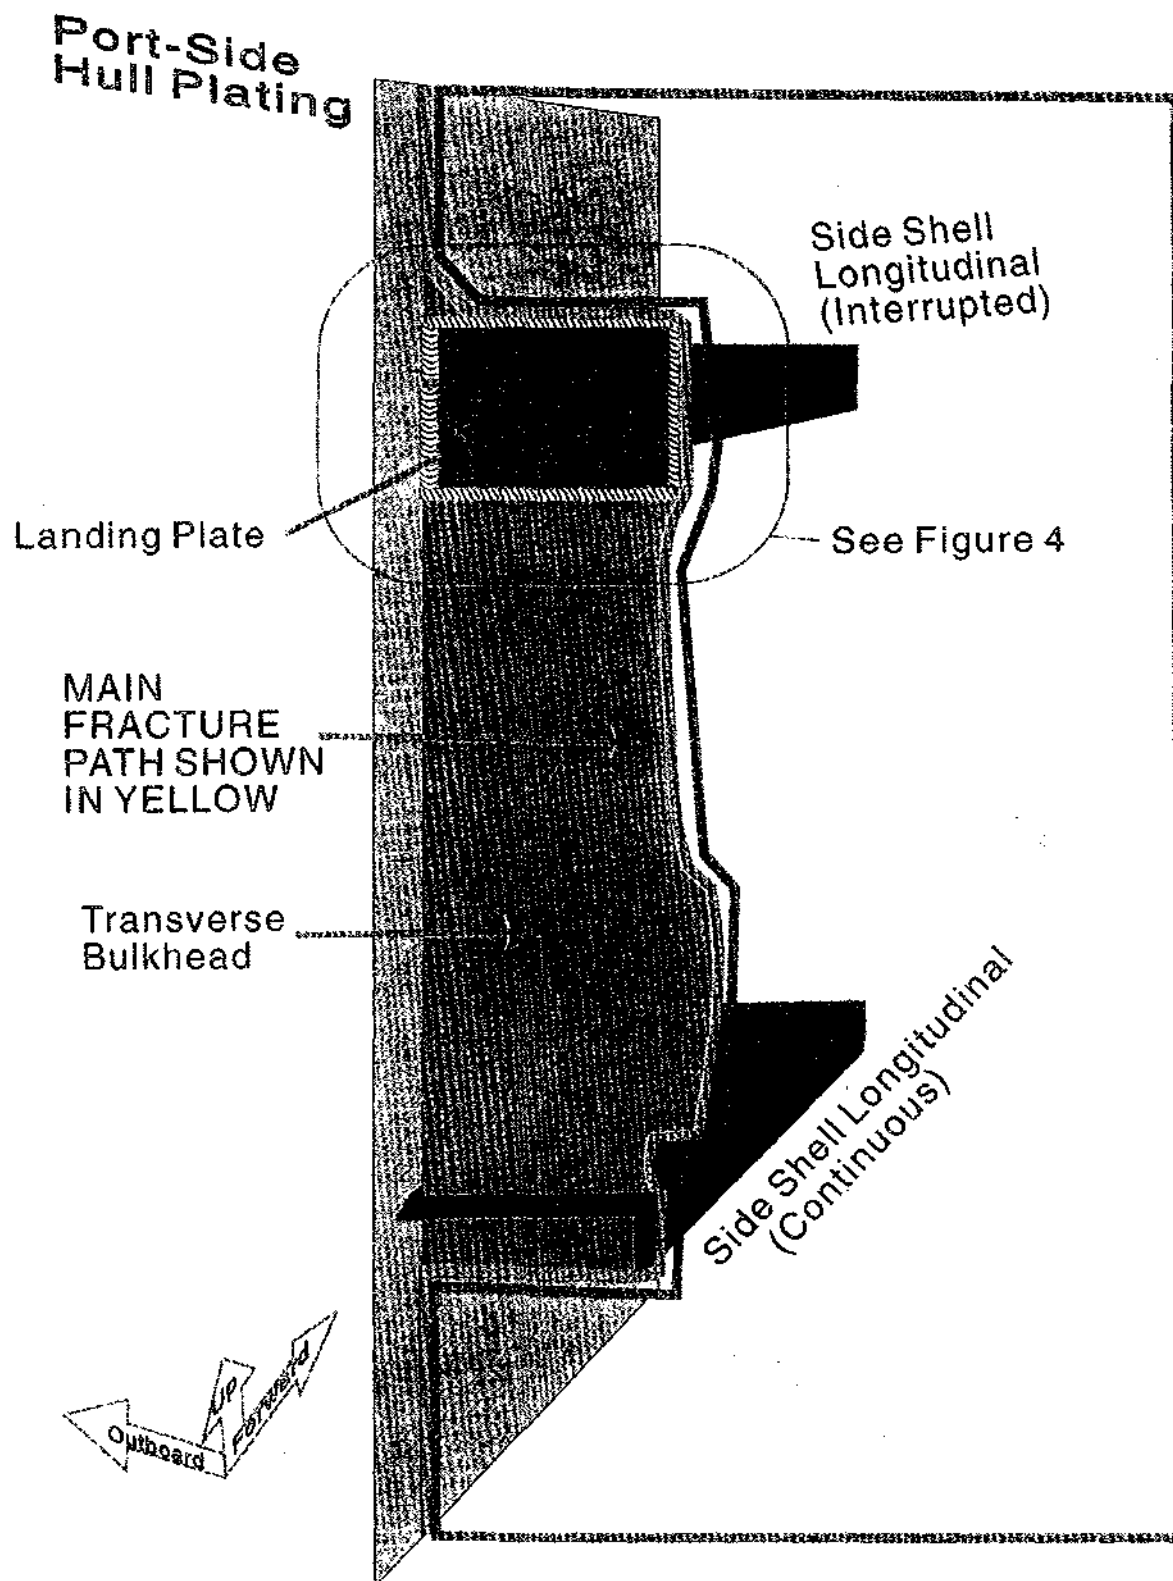
Figure 3 A drawing illustrating the arrangement of components. The main fracture path through the transverse bulkhead is denoted by the yellow line. The larger inboard piece of the bulkhead is shown as an outline for clarity. View is not to scale and shown without deformation.
