Investigation Report

Worker fatally injured after exposure to Hydrogen Sulphide

January 27, 2018

Report No-F-OHS-137943-3AC68

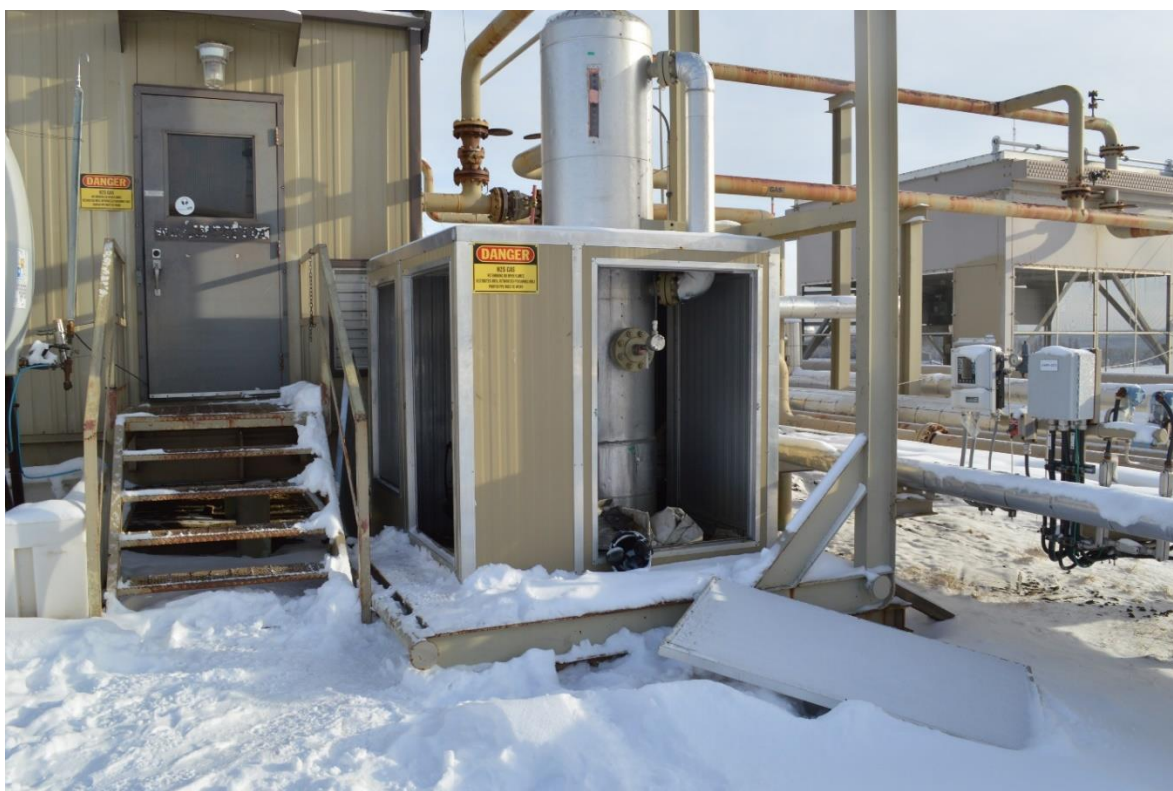
The cyclone separator was attached to the dehydration building and was used to remove water from the oil/gas before additional processing (Figure 1).

*Figure 1. Utilidor cyclone separator where Operator 1 was found.*

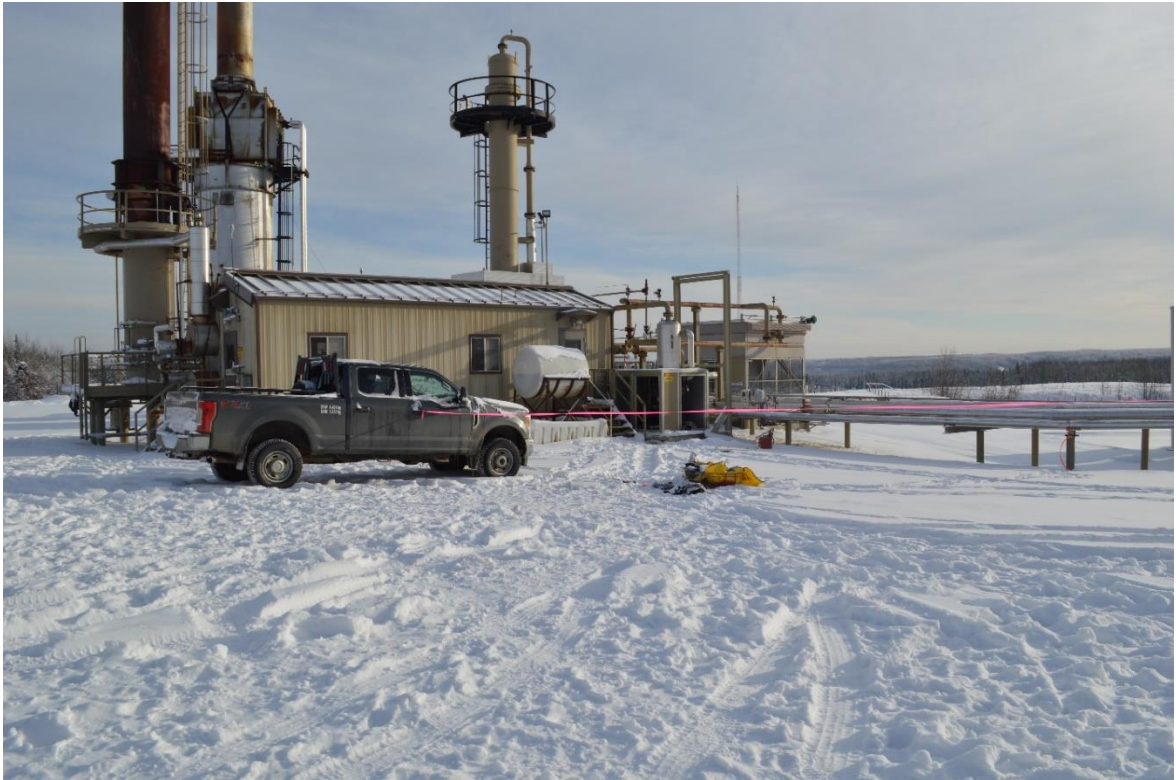
*Figure 2. Operator 1's work truck near the dehydration building and the cyclone separator.*

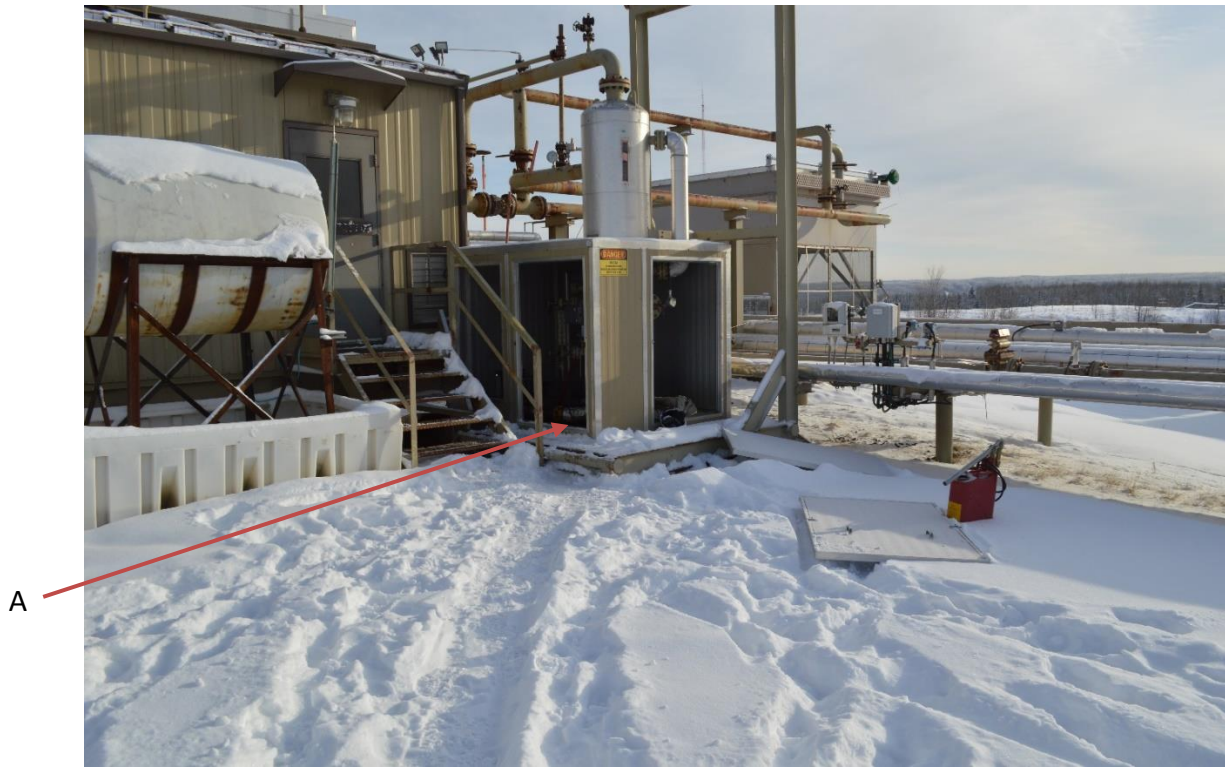
*Figure 3. Door where Operator 2 first saw Operator 1 unresponsive partially inside the cyclone separator utilidor.*

*A. Approximate position of Operator 1 inside the cyclone-separator utilidor*

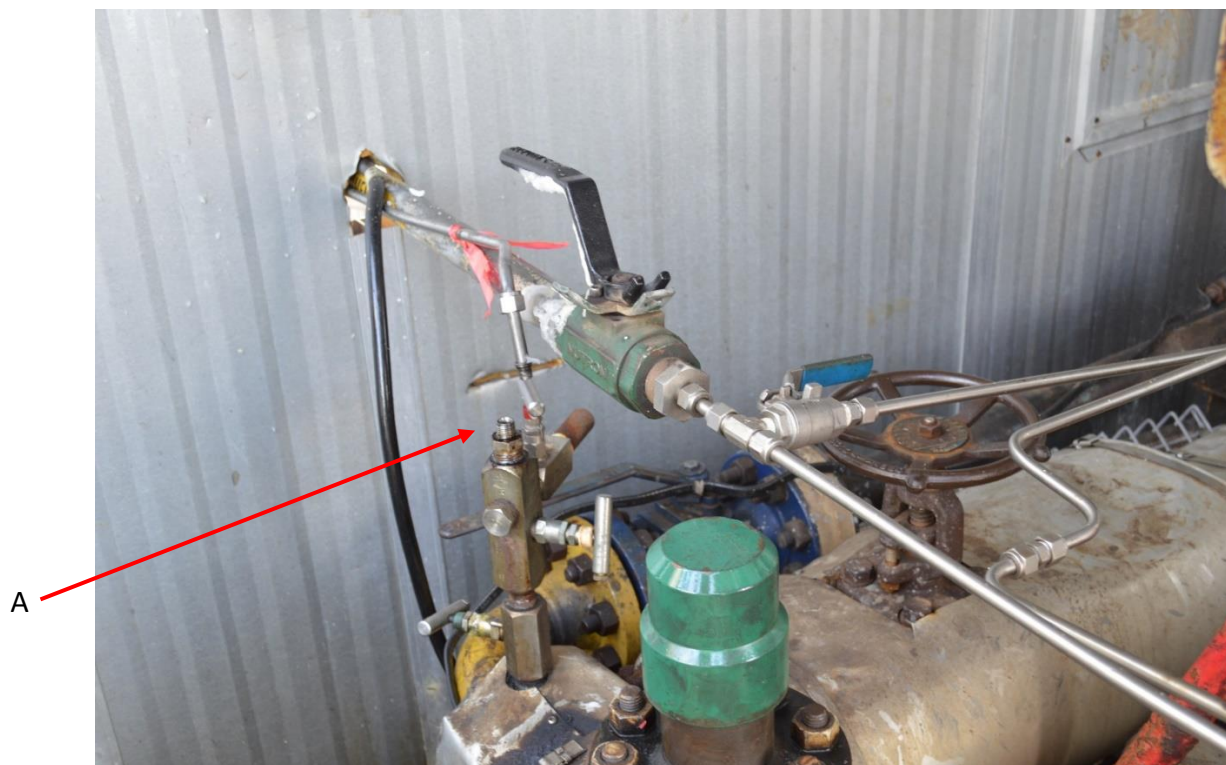
Operator 1 (fatally injured worker) had been working to unblock a needle valve of the cyclone separator where methanol was injected into the dump line. Operators were responsible for monitoring the facility, maintenance, well checks, and maintaining wells in the field. Operator 1 had 30 years of experience as a production field operator. Operator 1 had worked at the Simonette Oil Battery for 10 years as a senior operator with Trilogy; they stayed on as a Paramount employee and had many years of experience as a production operator in sour (hydrogen sulphide) service. Operator 1 had completed mandated safety training.

*Figure 5. Valve Operator 1 was working to unblock.*

*A. Open needle valve (methanol injection into dump line)*
