# The Report

# The High-Power Committee

The Styrene Vapour Release Accident at  
M/s LG Polymers India Pvt. Ltd.

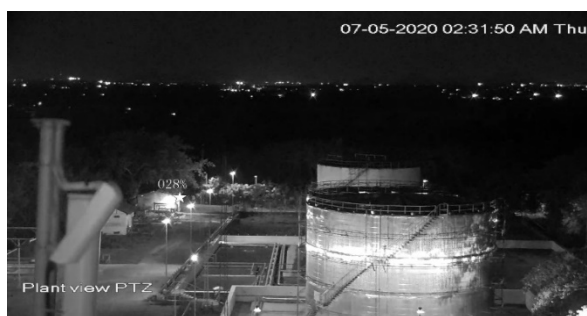
- 02:31 a.m.: No Styrene vapour release captured in the CCTV Figure 2.1

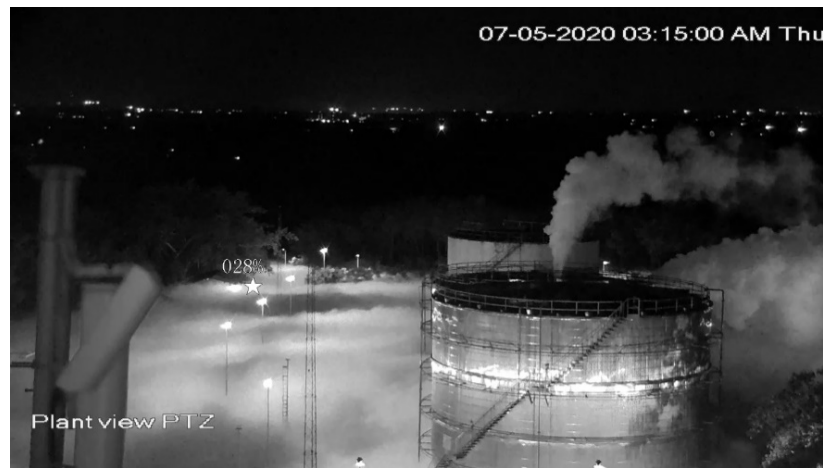
*Figure 2.7*

- 03:15 a.m.: The premises covered with dense Styrene vapour cloud

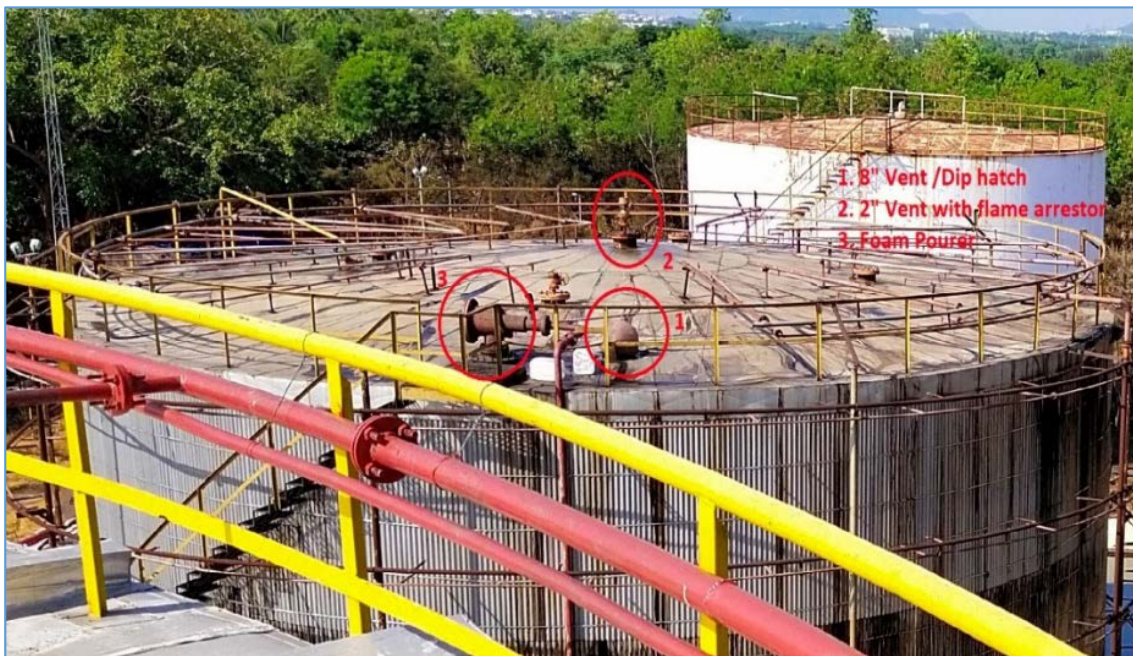
The photograph of the top of the tank, showing N1: Vent / Dip Hatch (S.No. 1 below), N6: Flame Arrestor / Vent (S.No. 2 below) and N2: Manhole / Foam Pourer (S.No. 3 below) is as below in Figure 2.9.

Figure 2.9: Roof Top of M6 Tank Showing Vents

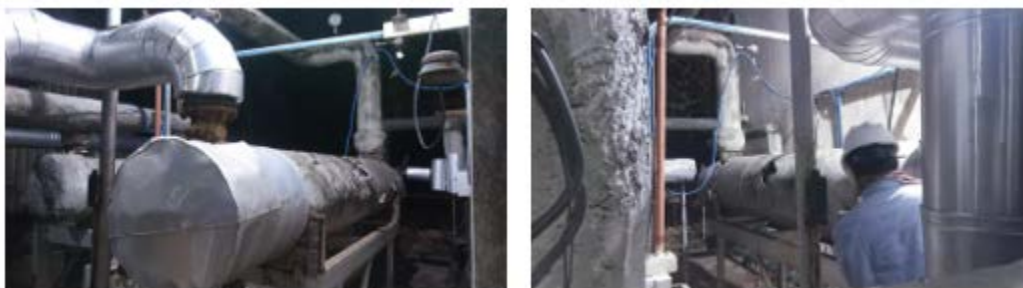
As per the report of the Technical Committee, on inspection of the refrigeration unit, it was observed that the insulation of the pipelines and equipment were damaged, and the rusted flanges can also be seen in figures 2.17 and figure 2.18 below. Under these circumstances, **the possible leak of R-22 into the recirculating Styrene cannot be ruled out.**

*Figure 2.17 and Figure 2.18: Present status of the refrigeration system and the alarm*
